WRANGELL COOPERATIVE ASSOCIATION
Shakes Island Renovation Project

P.O. Box 2021 • Wrangell, Alaska 99929

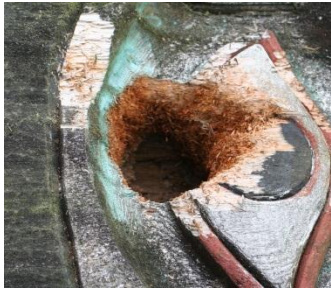
Woodpecker damage on Eagle totem pole.

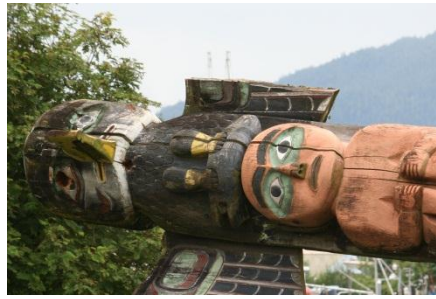
Missing wing and cracks in Eagle figure on Eagle totem pole.

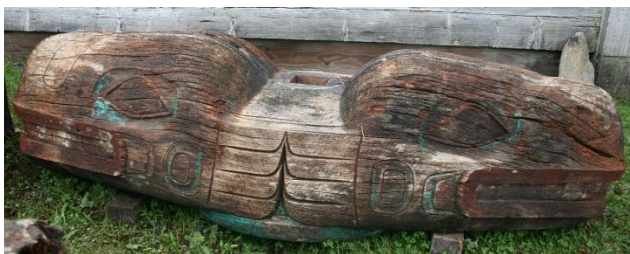
Double Whale Crest with missing top pieces and extensive rot.

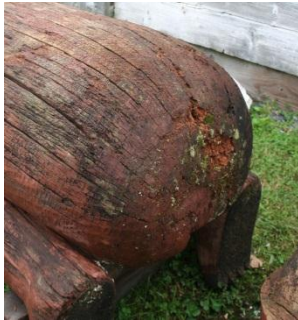
Bear figure with rot on bottom.

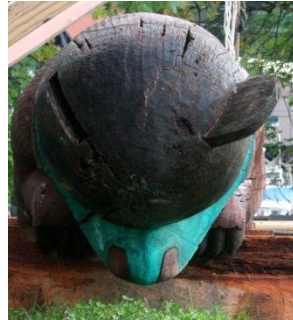
Bear figure with rot on head and missing ear.

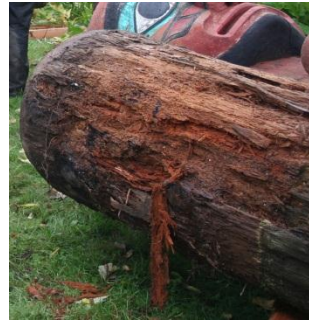
Base of column with rot damage.

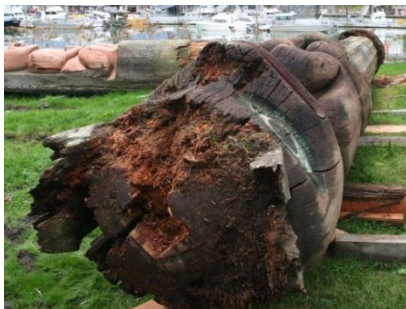
Head of Undersea Bear after cleaning and removal of plant material displaying extensive rot.

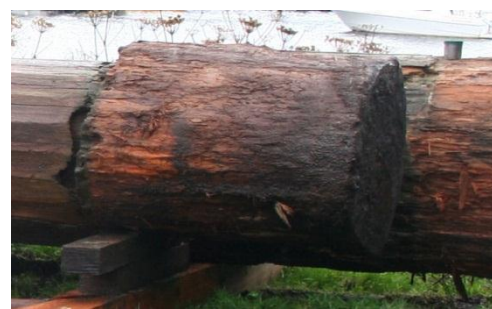
Rot and damage on base of Undersea Bear.

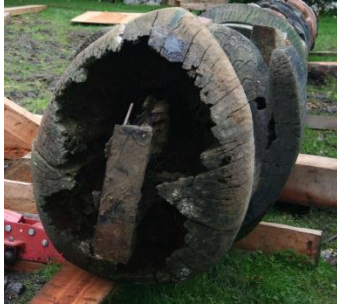
Top figure of the Chief Kadashan Crane totem displaying extensive rot.

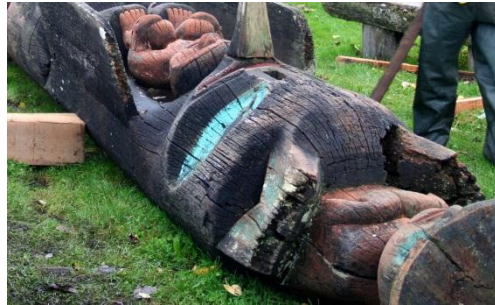
Top figure of the Chief Kadashan Red Snapper totem displaying rot.

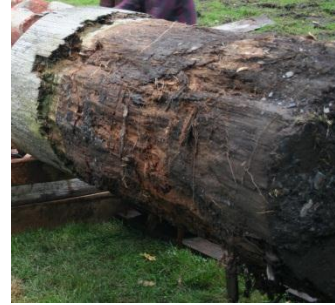
Rot and damage on base of Chief Kadashan Crane totem.
